Manhole Inspection Summary

Manhole # **S17K__031MH**

Location Address: **2401 FREDERICK AV**

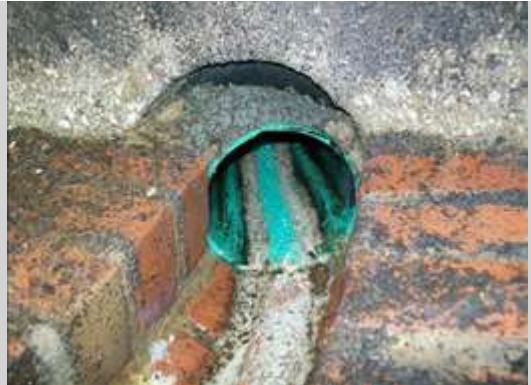
12 O'Clock Outflow

6 in. Circular Gravity Sewer
Pipe Out @ 12 O'Clock

Pipe Height: **6** (in.) Rod and Bar (Angled)
Pipe Material: **PVC** ☐ Pipe Lined
Invert Depth: **7.30** (ft.) Flow Characteristics: **Slow**
Deposits: ☒ None ☐ Mud ☐ Sludge ☐ Debris ☐ Grease
Silt Depth: **0** (in.) Deposits Extent:
Infiltration: **None** Pipe Seal Cond: **Sound**

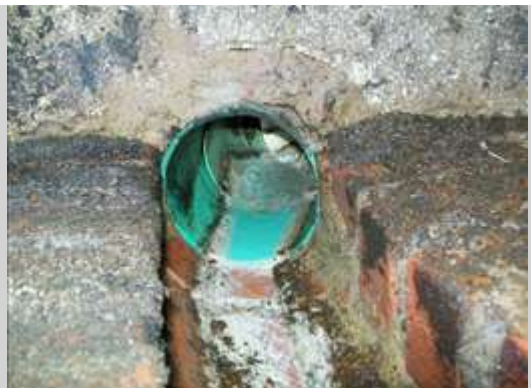
8 O'Clock Inflow

6 in. Circular Gravity Sewer
Pipe In @ 8 O'Clock

Pipe Height: **6** (in.) Rod and Bar (Angled)
Pipe Material: **PVC** ☐ Pipe Lined
Invert Depth: **7.10** (ft.) Flow Characteristics: **Slow**
Deposits: ☒ None ☐ Mud ☐ Sludge ☐ Debris ☐ Grease
Silt Depth: **0** (in.) Deposits Extent:
Infiltration: **None** Pipe Seal Cond: **Sound**
